Title: Science, value and material decay in the conservation of historic environments

**Science, value and material decay in the conservation of historic
environments**

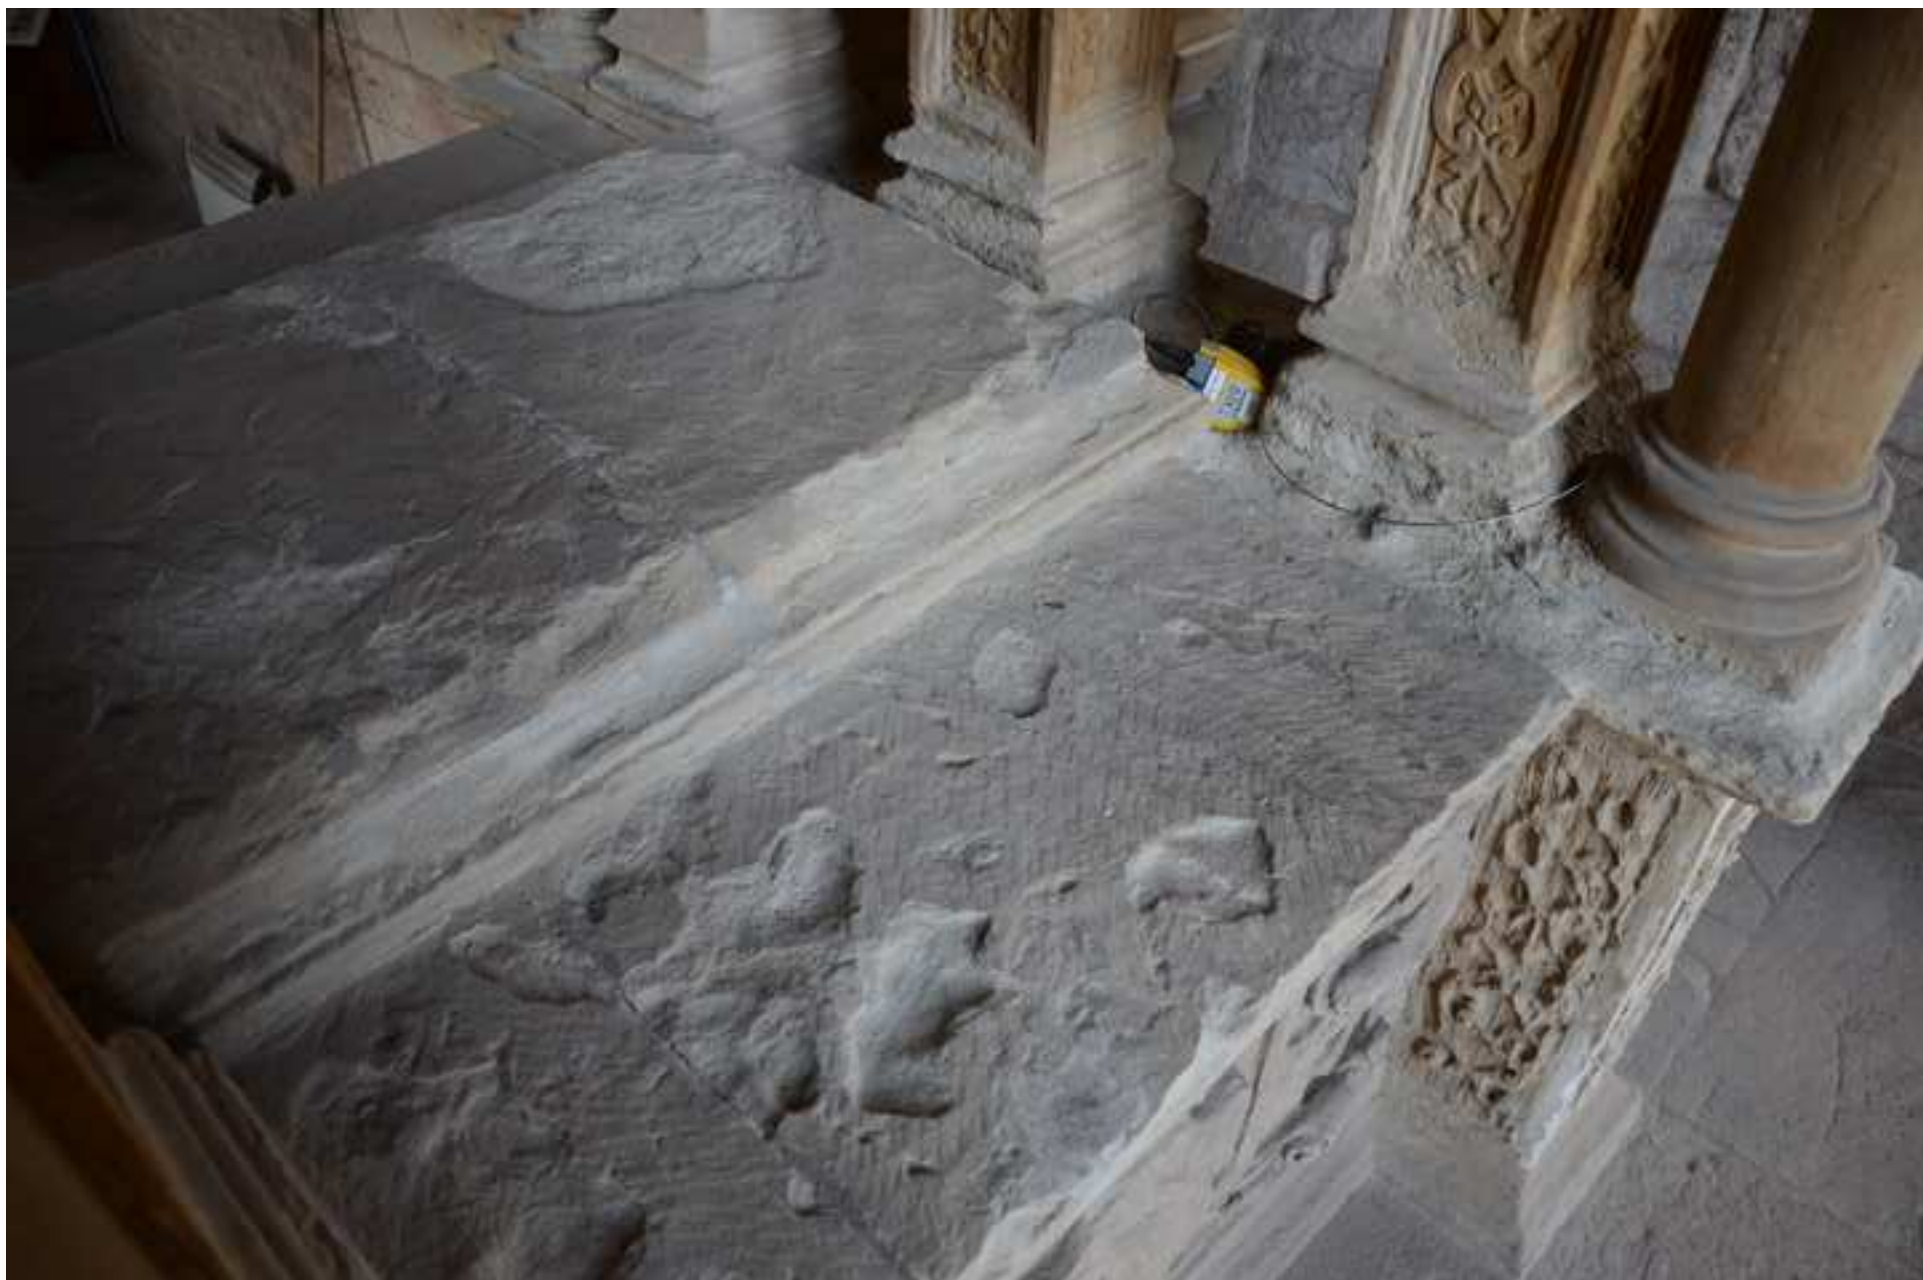
Figure 5. Decay on the top of the tomb at the Skelmorlie Aisle, Largs. Here the dense fine grained sandstone is suffering from cratering and powdering. At the centre top right of the image an environmental logging device can be seen attached to the structure, recording conditions of Temperature and Relative Humidity near to where damage is occurring. (Photograph: Maureen Young, Historic Environment Scotland).

17 The ceiling paintings are in a good state of preservation. The tomb canopy is
18 faring less well. Although the upper stonework is crisp, the lower parts appear
19 badly decayed. Granular disintegration and exfoliation (Fig 5) has been evident
20 since the mid 20th century, manifesting as craters, flaking and powdering on the
21 surface. Indeed, records show that in 1940 powdered surfaces were treated with
22 Magnesium Fluorosilicate with little evident success. In places, a thin crust has
23 formed, with disintegration continuing beneath. So far, the decay has been

1 attributed to high moisture levels and possible salt contamination. There are also
2 damp patches and salt efflorescence on the walls of the Aisle, which are
3 constructed from course ashlar. The south wall is a particular concern, because it
4 originally consisted of an internal wall with a pointed arch that was blocked and
5 rendered (‘harled’ in Scotland) externally after the rest of the church was
6 demolished.
